**Flood Control Project Maintenance  
Levee Inspections**

**Fall 2012 Levee Maintenance Deficiency Summary Report**

**Reclamation District No. 2031 Elliot**

**Fall 2012 Levee Inspection Results**

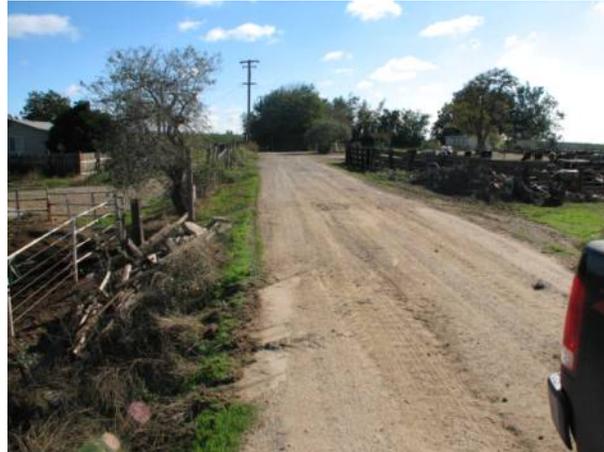
mkhashch\_f\_20120927\_063.jpg

Fall 2009 photo looking upstream at beginning of unit 1. Water side to the left.

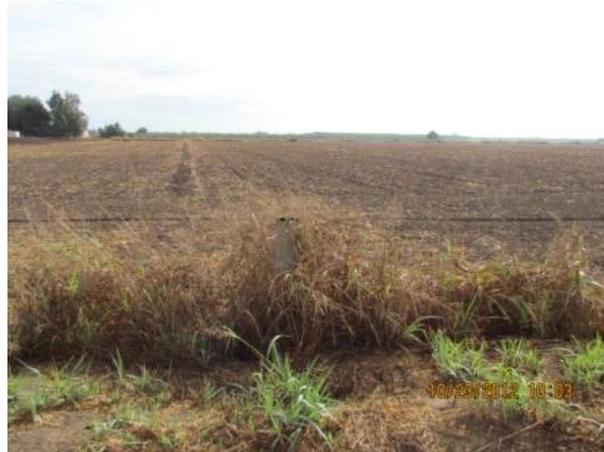
Levee Mile Report Line	5
Start Levee Mile	0.15
End Levee Mile	0.15
Location	Land Side
Category	Earthen Levee
Item	Encroachments

View of the pipe in landward slope of levee facing downstream.

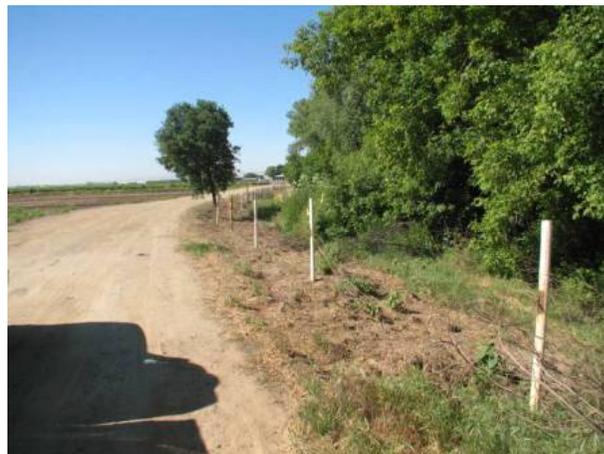
Levee Mile Report Line	6
Start Levee Mile	0.34
End Levee Mile	0.52
Location	Water Side
Category	Earthen Levee
Item	Encroachments

05/10/2011 Fence on waterside prevents access to waterside slope.

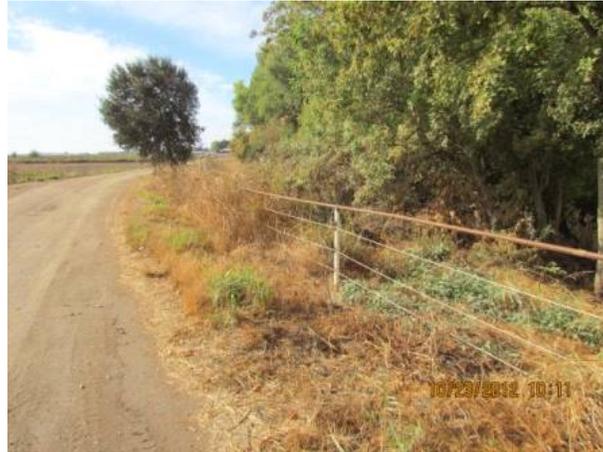
Levee Mile Report Line	6
Start Levee Mile	0.34
End Levee Mile	0.52
Location	Water Side
Category	Earthen Levee
Item	Encroachments
View of fence on waterside slope facing downstream.	
mkhashch_f_20121029_682.JPG

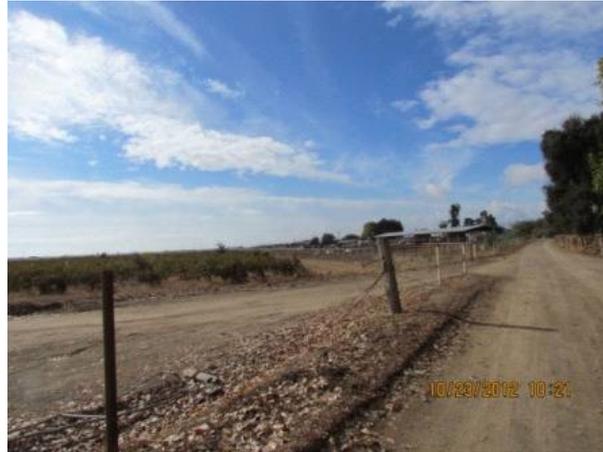
Levee Mile Report Line	8
Start Levee Mile	0.45
End Levee Mile	0.52
Location	Land Side
Category	Earthen Levee
Item	Encroachments
View of fence on landside levee shoulder facing downstream.	
mkhashch_f_20121029_685.JPG

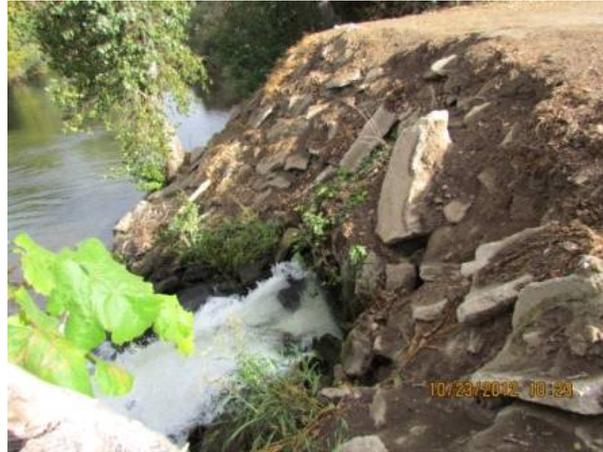
mkhashch\_f\_20121029\_687.JPG

View of missing flap gate. Facing upstream.

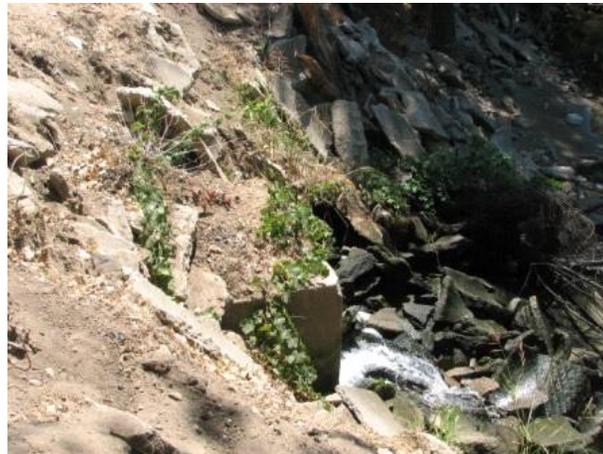
Levee Mile Report Line	10
Start Levee Mile	0.47
End Levee Mile	0.50
Location	Water Side
Category	Supplemental
Item	DWR Erosion Survey

Direct view of the site.

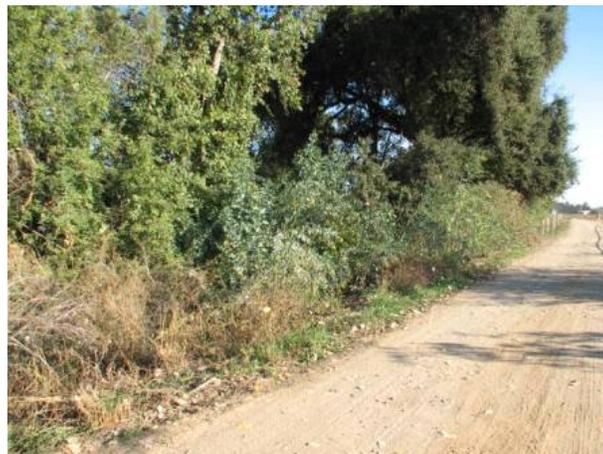
Levee Mile Report Line	11
Start Levee Mile	0.52
End Levee Mile	0.52
Location	Water Side
Category	Earthen Levee
Item	Vegetation

10/26/2011 Updated photo of waterside vegetation.

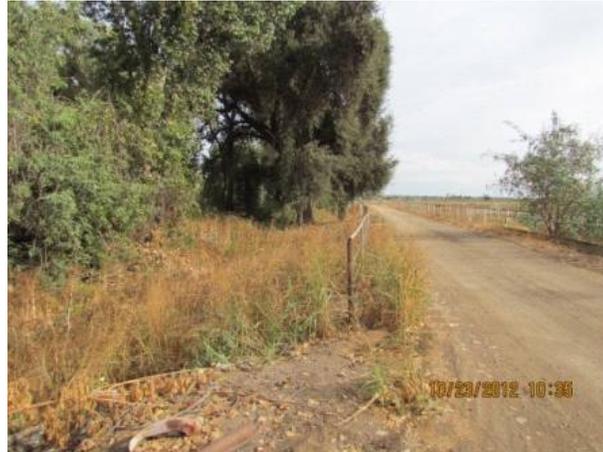
Levee Mile Report Line	11
Start Levee Mile	0.52
End Levee Mile	0.52
Location	Water Side
Category	Earthen Levee
Item	Vegetation
View of vegetation on waterside slope. Facing upstream.	
mkhashch_f_20121029_688.JPG

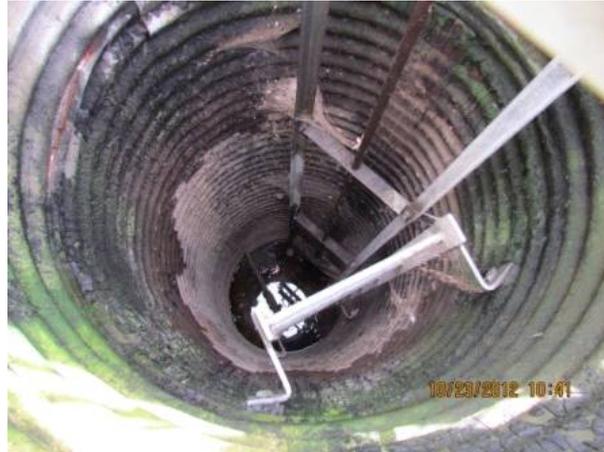
mkhashch\_f\_20121029\_689.JPG

View of slide gate and access ladder. Gate appears to be in good condition.

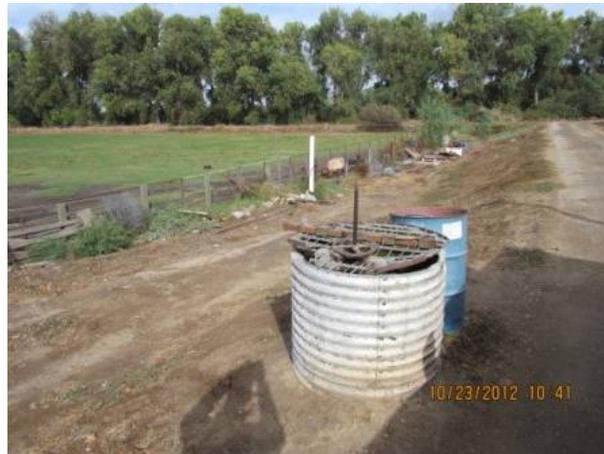
Levee Mile Report Line	13
Start Levee Mile	0.57
End Levee Mile	0.57
Location	Water Side
Category	Earthen Levee
Item	Encroachments

View of the pipe gate valve location.

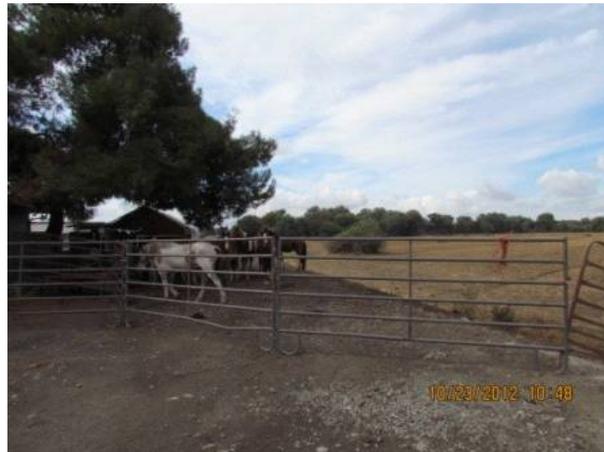
Levee Mile Report Line	14
Start Levee Mile	0.61
End Levee Mile	0.61
Location	Crown
Category	Earthen Levee
Item	Encroachments

View of temporary gate across levee crown, facing downstream.

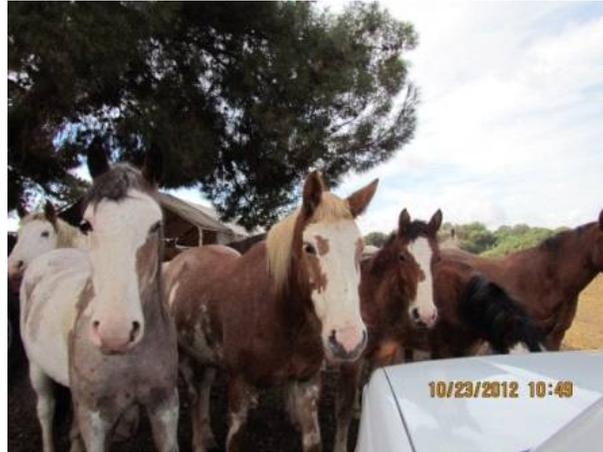
mkhashch\_f\_20121029\_694.JPG

View of livestock on levee crown.

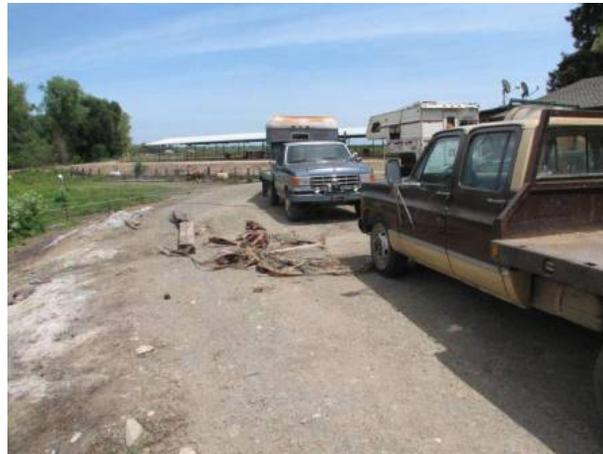
Levee Mile Report Line	15
Start Levee Mile	0.63
End Levee Mile	0.63
Location	Crown
Category	Earthen Levee
Item	Encroachments

View of vehicles parked on crown of levee, facing upstream. 05/02/2012

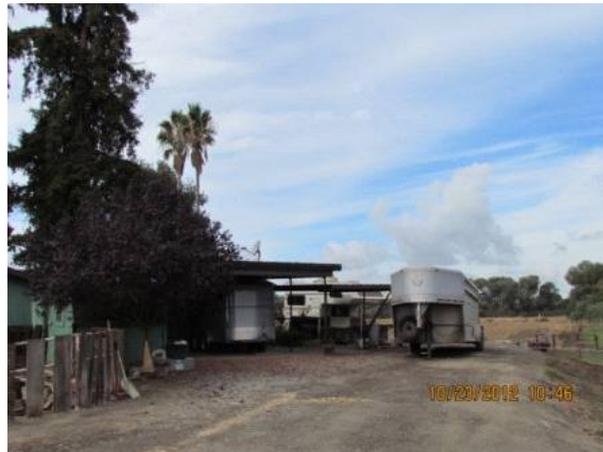
Levee Mile Report Line	15
Start Levee Mile	0.63
End Levee Mile	0.63
Location	Crown
Category	Earthen Levee
Item	Encroachments

View of vehicles/equipment parked on crown of levee, facing downstream.

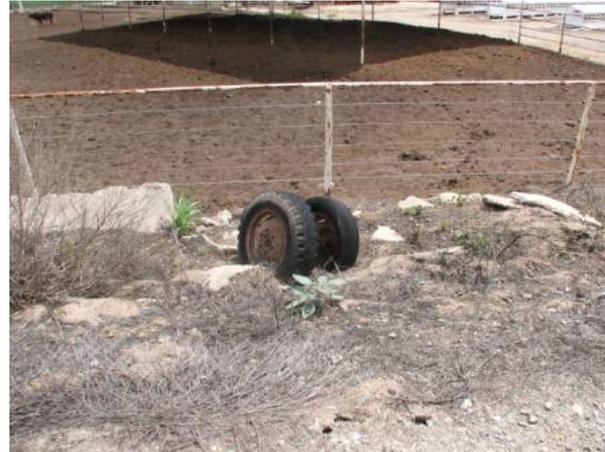
Levee Mile Report Line	18
Start Levee Mile	0.65
End Levee Mile	0.65
Location	Land Side
Category	Earthen Levee
Item	Encroachments
View of tractor wheels on landward slope. 05/02/2012	
mkhashch_f_20120927_061.jpg

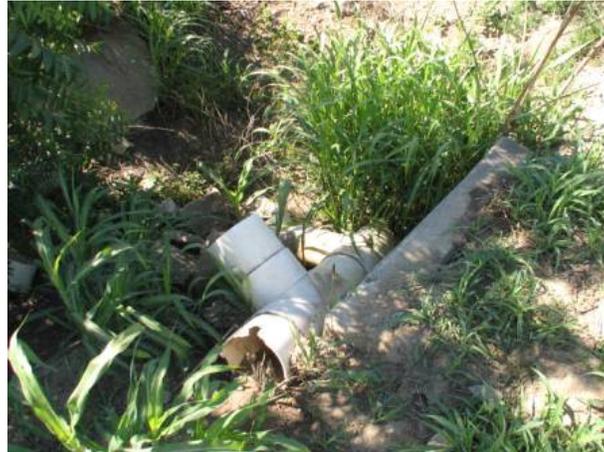
Levee Mile Report Line	21
Start Levee Mile	0.81
End Levee Mile	0.81
Location	Land Side
Category	Earthen Levee
Item	Encroachments
05/10/2011 PVC pipe pieces are obstructing opening to drain pipe.	
mkhashch_f_20120927_056.jpg

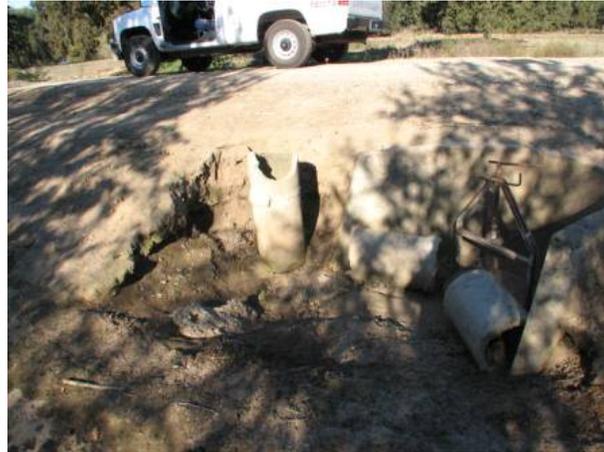
Levee Mile Report Line	24
Start Levee Mile	1.58
End Levee Mile	1.58
Location	Land Side
Category	Earthen Levee
Item	Erosion / Bank Caving
10/26/2011 Active erosion into the levee prism around irrigation standpipe.	
mkhashch_f_20120927_050.jpg

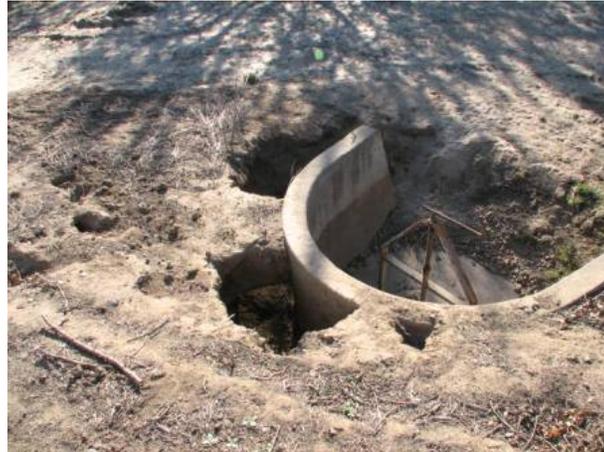
Levee Mile Report Line	26
Start Levee Mile	1.65
End Levee Mile	1.65
Location	Land Side
Category	Earthen Levee
Item	Erosion / Bank Caving
10/26/2011 Active erosion into levee prism around irrigation inlet.	
mkhashch_f_20120927_053.jpg

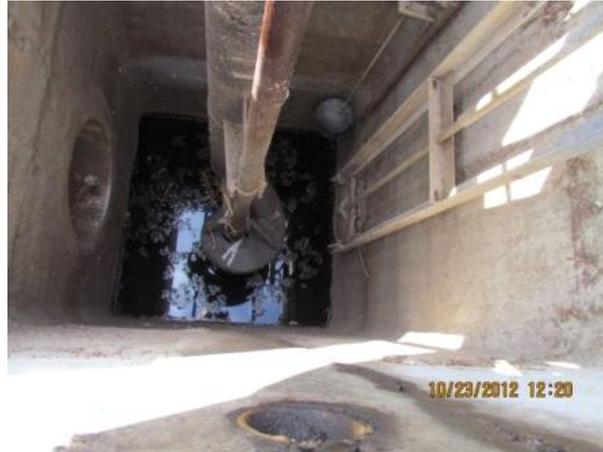
mkhashch\_f\_20121029\_700.JPG

View of the closed slide gate.

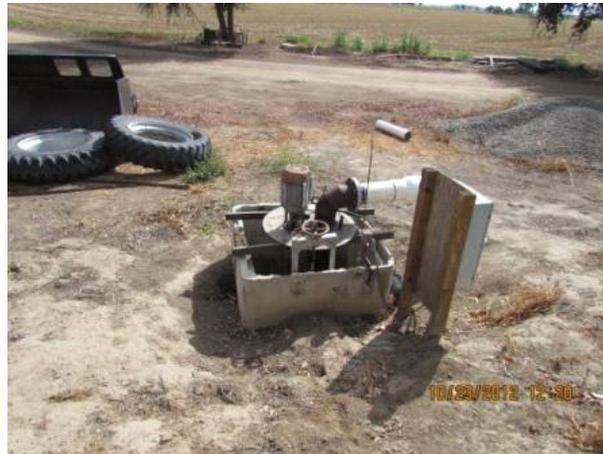
Levee Mile Report Line	30
Start Levee Mile	2.41
End Levee Mile	2.41
Location	Land Side
Category	Earthen Levee
Item	Encroachments

View of the slide gate lever and well.

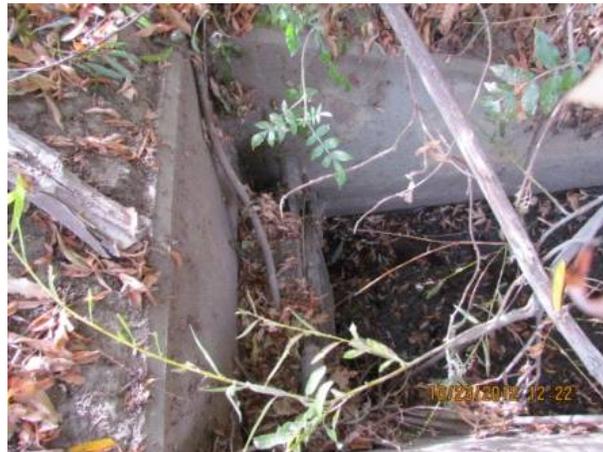
Levee Mile Report Line	30
Start Levee Mile	2.41
End Levee Mile	2.41
Location	Land Side
Category	Earthen Levee
Item	Encroachments

View of closed flap gate on waterside.

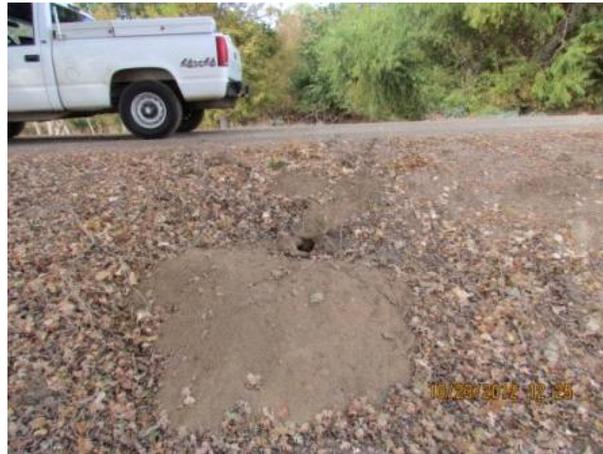
LMIR No.	Levee Mile		Category	Item	Location	Rating	Action/Comment	GPS Latitude/Longitude		Issue No. Photo
	Start	End						Start	End	
31	2.44	2.44	Earthen Levee	Animal Control	LS	U	A3 : No rodents visible, but rodent burrows visible; need to backfill and compact or grout burrows. Inspector Comments: Large rodent holes were noted on the landside slope.	37.688388 ° -121.180135 °	37.688388 ° -121.180135 °	43 Y
DWR ID: DWR_RD2031_01_f_2012_43										
32	2.47	2.47	Earthen Levee	Encroachments	WSA/W	PI : Pipe	Ma	37.687953 ° -121.180244 °	37.687953 ° -121.180244 °	15 Y
DWR ID: DWR_RD2031_01_s_2012_15										
33	2.56	2.56	Earthen Levee	Animal Control	CR	M	A3 : No rodents visible, but rodent burrows visible; need to backfill and compact or grout burrows. Inspector Comments: Several rodent holes observed on the levee crown.	37.687397 ° -121.181565 °	37.687397 ° -121.181565 °	44 Y
DWR ID: DWR_RD2031_01_f_2012_44

Levee Mile Report Line	31
Start Levee Mile	2.44
End Levee Mile	2.44
Location	Land Side
Category	Earthen Levee
Item	Animal Control
View of large animal burrow on landside slope with lots of material removed from the levee.	
mkhashch_f_20121029_703.JPG

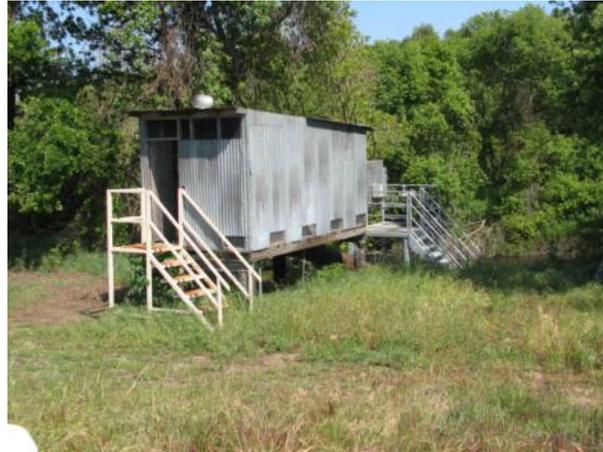
Levee Mile Report Line	40
Start Levee Mile	3.72
End Levee Mile	3.72
Location	Water Side
Category	Earthen Levee
Item	Encroachments
Irrigation intake on waterside berm.	
mkhashch_f_20120927_055.jpg

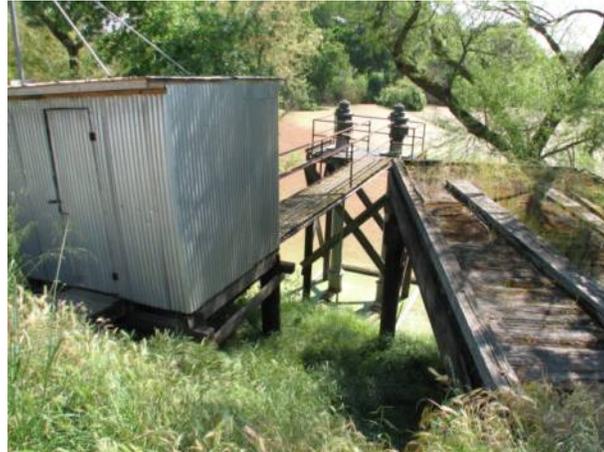
Levee Mile Report Line	1
Start Levee Mile	0.22
End Levee Mile	0.22
Location	Land Side
Category	Earthen Levee
Item	Encroachments
Drainage discharge pumps and housing on steep waterside slope.	
mkhashch_f_20120927_070.jpg

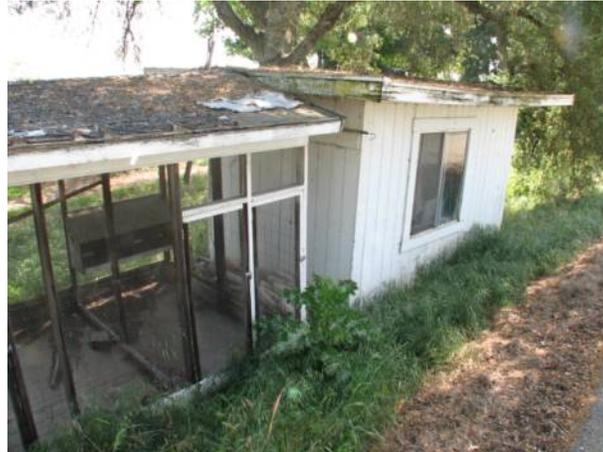
Levee Mile Report Line	3
Start Levee Mile	1.36
End Levee Mile	1.36
Location	Land Side
Category	Earthen Levee
Item	Encroachments
Small structure on levee slope.	
mkhashch_f_20120927_072.jpg

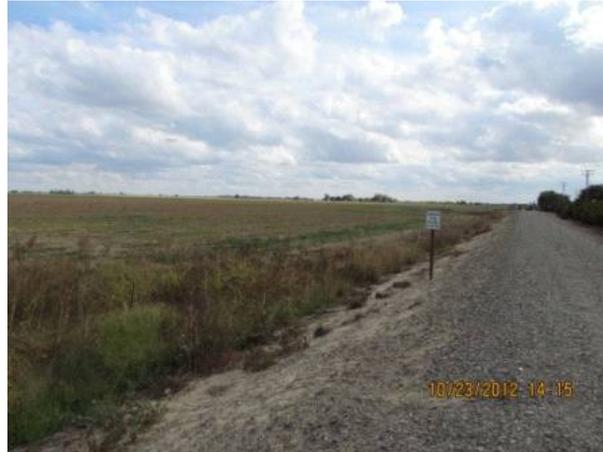
Levee Mile Report Line	7
Start Levee Mile	3.89
End Levee Mile	3.89
Location	Land Side
Category	Earthen Levee
Item	Vegetation
Tall vegetation on landside toe obstructing visibility.	
mkhashch_f_20121105_708.JPG

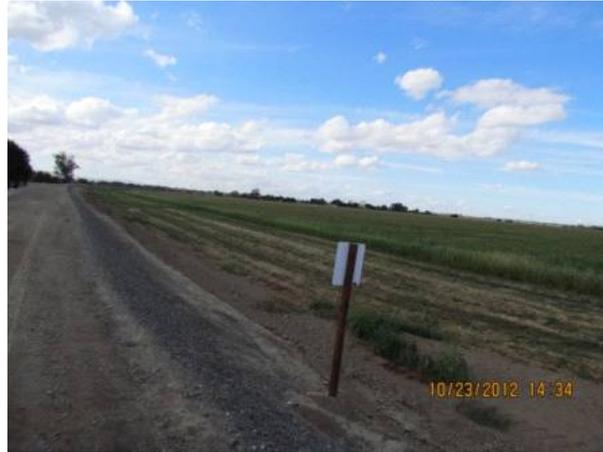
Levee Mile Report Line	9
Start Levee Mile	4.23
End Levee Mile	4.73
Location	Land Side
Category	Earthen Levee
Item	Encroachments
View of agricultural tilling up to landside toe looking west from LM 4.47.	
mkhashch_f_20121105_712.JPG

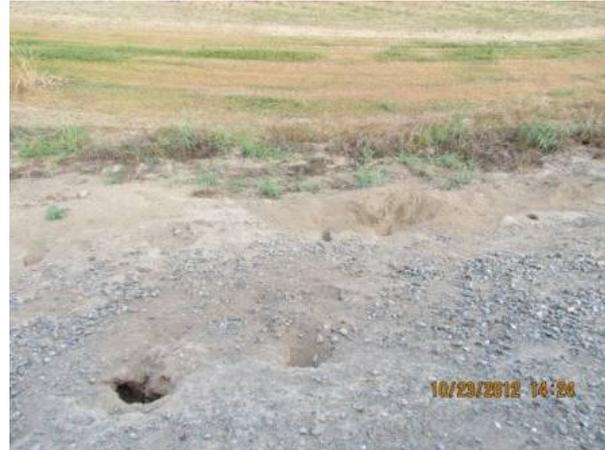
mkhashch\_f\_20121105\_709.JPG

View of active burrows on landside slope and toe.

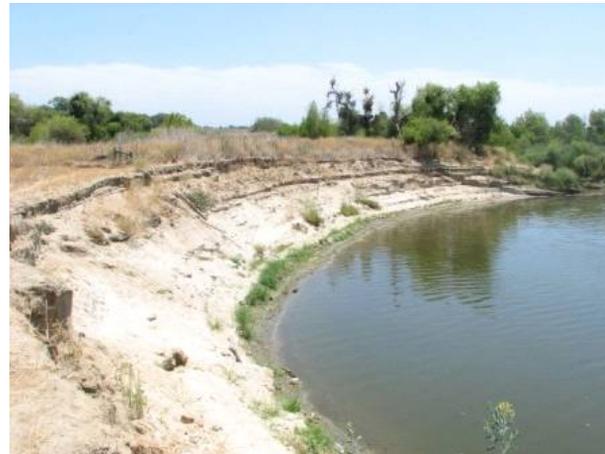
Levee Mile Report Line	11
Start Levee Mile	4.33
End Levee Mile	4.37
Location	Water Side
Category	Supplemental
Item	DWR Erosion Survey

LMR No.	Levee Mile		Category	Item	Location	Rating	Action/Comment	GPS Latitude/Longitude		Issue No. Photo
	Start	End						Start	End	
11	4.33	4.37	Supplemental	DWR Erosion Survey	WSA/W	Ma	Inspector Comments: 07/18/2012: No significant change observed on the site. 08/18/2011: No significant changes observed on the site. Dead trees and animal activities visible. The closest point of the erosion site to the levee toe is about 100 ft. 10/19/2010: There is active scouring occurring on the bank due to the nature of the flow and the lack of armor protection. There is also a fallen log immediately downstream of where the erosion has occurred and is protruding outward, possibly creating an eddy and scouring the bank. With the remaining 100-foot wide berm, the levee prism is not yet affected. However, the bank will continue to degrade, and eventually intrude into the levee prism if no protection is put in place. Erosion site is recommended for annual assessment and monitoring during flood events. [2012 Site ID:RD2031U02RM78.7]	37.631716 ° -121.189370 °	37.631716 ° -121.189370 °	1 Y

From the berm looking downstream.

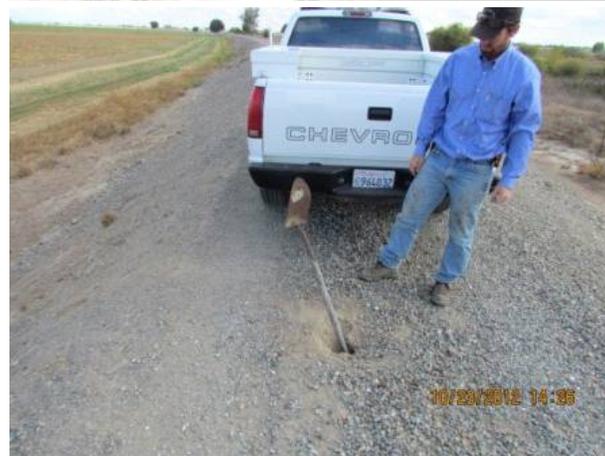
mkhashch\_f\_20121105\_711.JPG

View of large burrow in levee crown.

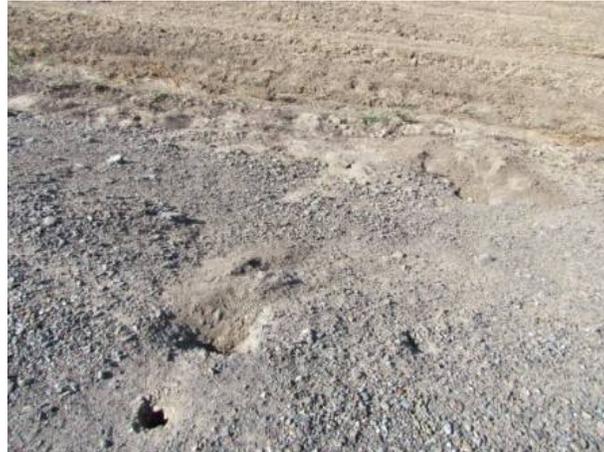
Levee Mile Report Line	13
Start Levee Mile	4.39
End Levee Mile	4.39
Location	Land Side
Category	Earthen Levee
Item	Animal Control
View of several active burrow holes at landside hinge and toe. 05/24/2012	
mkhashch_f_20120927_091.jpg

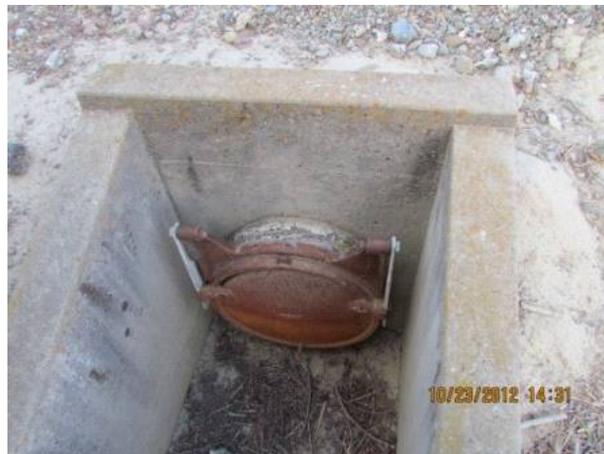
Levee Mile Report Line	14
Start Levee Mile	4.58
End Levee Mile	4.58
Location	Water Side
Category	Earthen Levee
Item	Encroachments
View of the closed flap gate on waterside.	
mkhashch_f_20121105_710.JPG

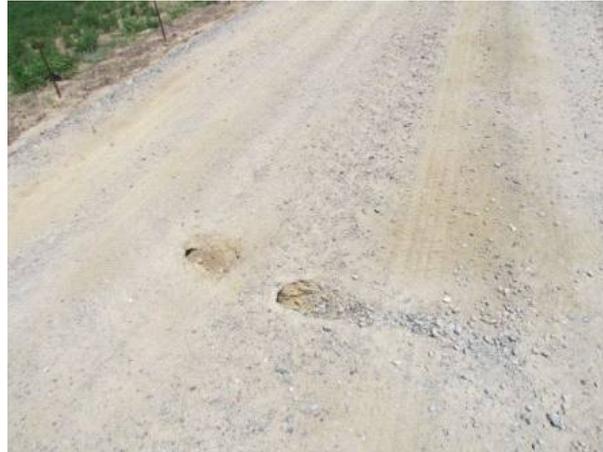
Levee Mile Report Line	16
Start Levee Mile	4.82
End Levee Mile	4.82
Location	Crown
Category	Earthen Levee
Item	Animal Control
View of rodent burrow in levee crown. 05/15/2012	
mkhashch_f_20120927_089.jpg

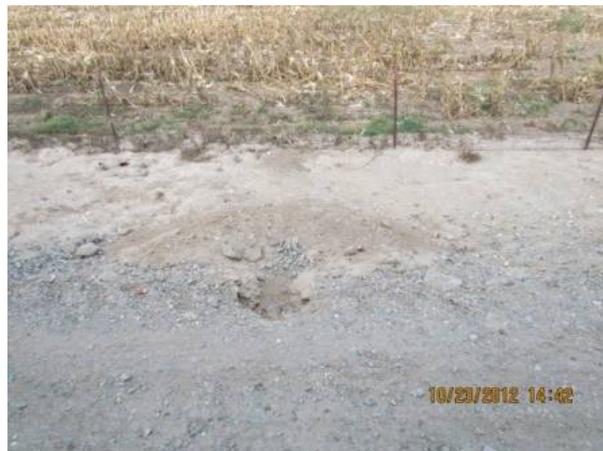
Levee Mile Report Line	17
Start Levee Mile	5.33
End Levee Mile	5.33
Location	Land Side
Category	Earthen Levee
Item	Animal Control
Landside photo of large burrow, 3-5 cubic ft of material shown.	
mkhashch_f_20121105_713.JPG

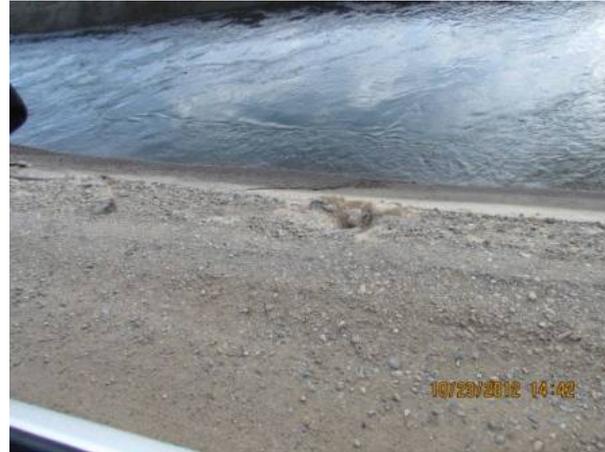
Levee Mile Report Line	17
Start Levee Mile	5.33
End Levee Mile	5.33
Location	Land Side
Category	Earthen Levee
Item	Animal Control
Waterside burrow, located almost directly across from large burrow in previous photo.	
mkhashch_f_20121105_714.JPG

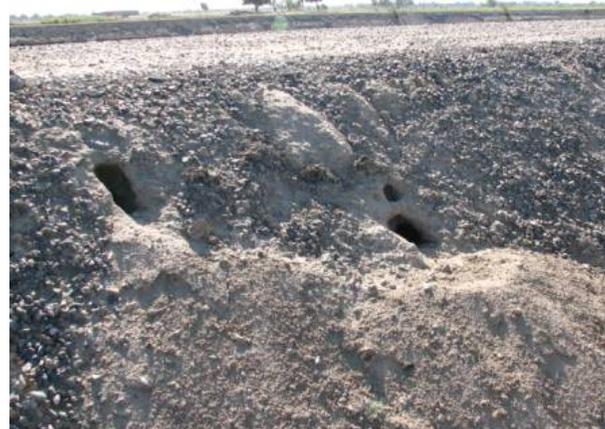
Levee Mile Report Line	18
Start Levee Mile	5.46
End Levee Mile	5.46
Location	Land Side
Category	Earthen Levee
Item	Animal Control
10/26/2011 Multiple burrows shown on the landside.	
mkhashch_f_20120927_083.jpg

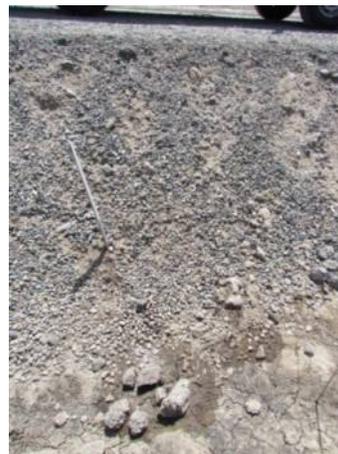
LMIR No.	Levee Mile		Category	Item	* Location	+ Rating	Action/Comment	GPS Latitude/Longitude		Issue No. Photo
	Start	End						Start	End	
19	5.51	5.51	Earthen Levee	Seepage / Sandboils	LS	A Ob		37.630485 ° -121.168648 °	37.630485 ° -121.168648 °	8 Y
DWR ID: DWR_RD2031_02_s_2012_8										
20	5.54	5.54	Earthen Levee	Seepage / Sandboils	LS	A Ob	Inspector Comments: 10/26/2011 Possible sand boil observed. Note that there is damage to the concrete channel directly across on the waterside of the levee from this issue. FIR filed for this issue, FIR no. 4422.	37.630797 ° -121.168204 °	37.630797 ° -121.168204 °	15 Y
DWR ID: DWR_RD2031_02_s_2012_15										
21	5.65	5.65	Earthen Levee	Erosion / Bank Caving	LS	U Ma	Inspector Comments: Active erosions occurring. Appears to be a hole behind the levee penetrating into the prism. Cracks observed above the hole on the levee slope. The waterside of the levee is a concrete lined MID irrigation canal.	37.630794 ° -121.166179 °	37.630794 ° -121.166179 °	16 Y

Levee Mile Report Line	19
Start Levee Mile	5.51
End Levee Mile	5.51
Location	Land Side
Category	Earthen Levee
Item	Seepage / Sandboils
View of seepage at toe; clear water present at the saturated spot. 05/15/2012	
mkhashch_f_20120927_073.jpg

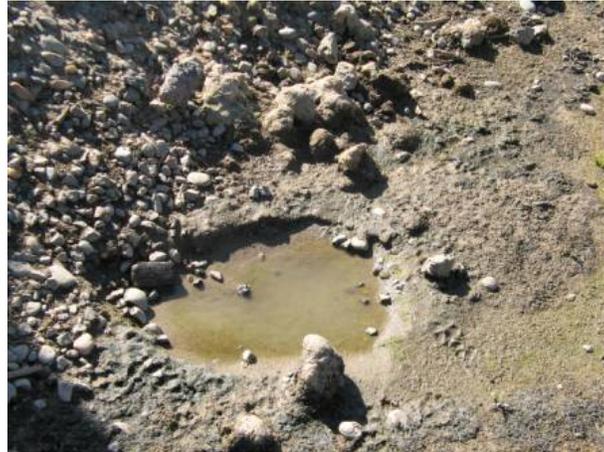
mkhashch\_f\_20120927\_084.jpg

10/26/2011 First of three photos showing possible sand boil, appears to be a deposition of material as evidenced by the shadows on the upper side of the boil.

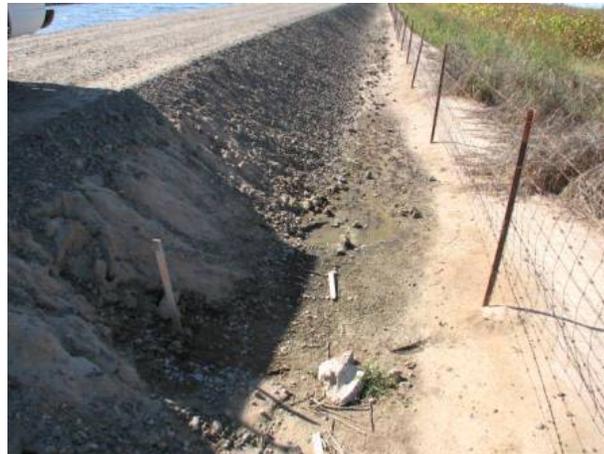
mkhashch\_f\_20120927\_085.jpg

10/26/2011 Photo shows location of boil relative to the levee.

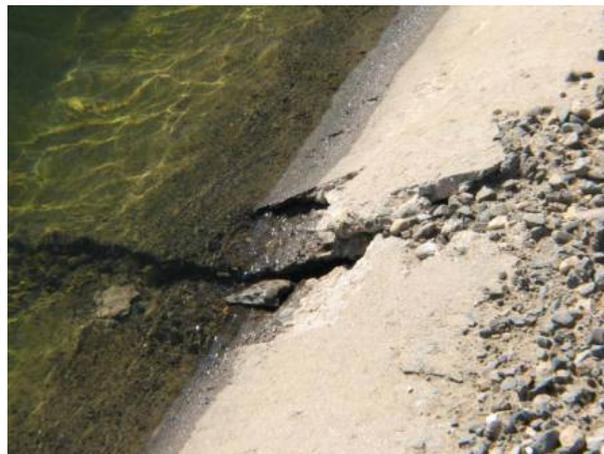
mkhashch\_f\_20120927\_086.jpg

10/26/2011 This concrete damage is located directly across the levee crown from the boil location.

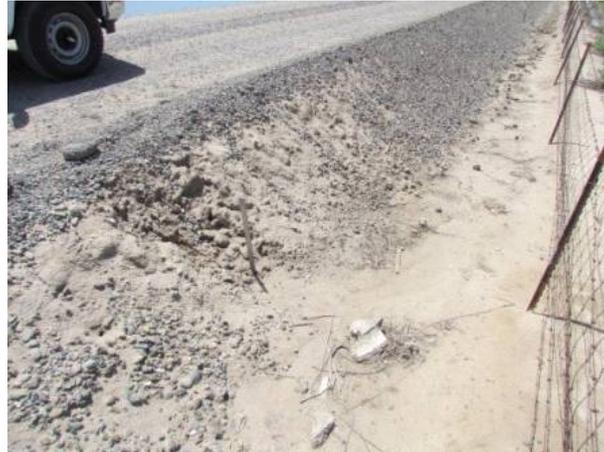
Levee Mile Report Line	20
Start Levee Mile	5.54
End Levee Mile	5.54
Location	Land Side
Category	Earthen Levee
Item	Seepage / Sandboils
View of the erosion site; not seepage visible at time of inspection. 05/15/2012	
mkhashch_f_20120927_087.jpg

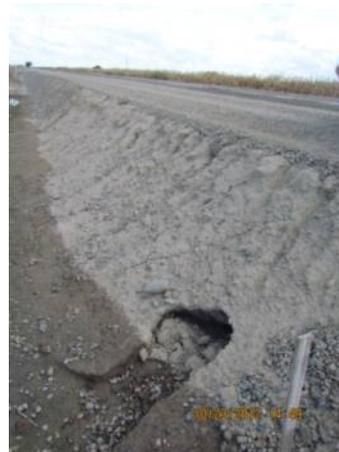
Levee Mile Report Line	21
Start Levee Mile	5.65
End Levee Mile	5.65
Location	Land Side
Category	Earthen Levee
Item	Erosion / Bank Caving
View of the erosion in relationship to the levee crown.	
mkhashch_f_20121105_715.JPG

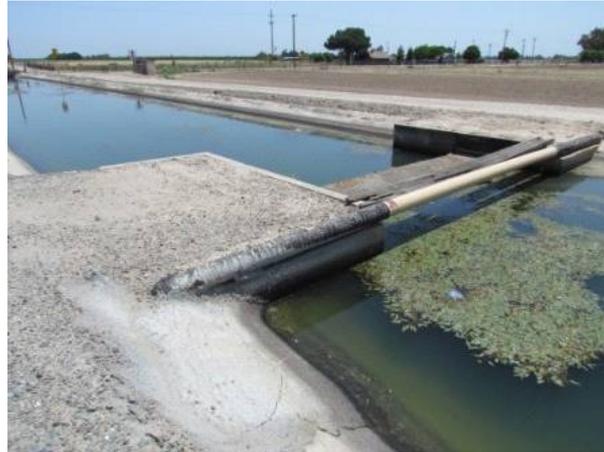
mkhashch\_f\_20120927\_069.jpg

View of gas pipeline penetrating levee. 05/15/2012
